# Manhole Inspection Summary

Manhole # S63C\_\_003MH

Insp Date: **3/11/10 11:08 AM**

**Location** Address: **Bioscience Dr.**

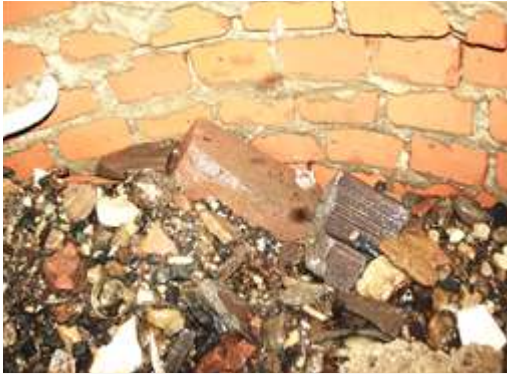
Defect 5

Condition: ☐ Sound ☐ Cracked ☐ Root Intrusion ☐ Deteriorated ☐ Leaks ☒ **Debris**

debris

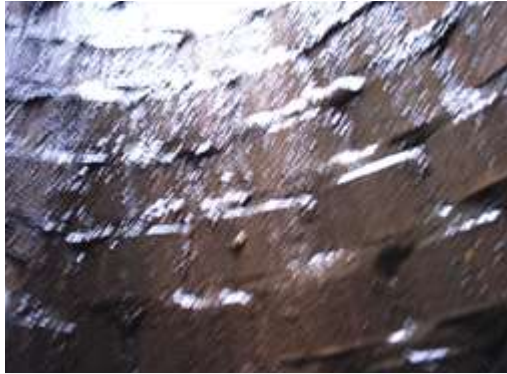
Defect 4

infiltration

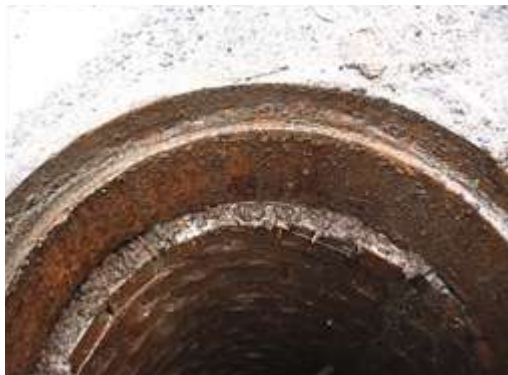
Defect 3

Offset: **2** (in.)

offset

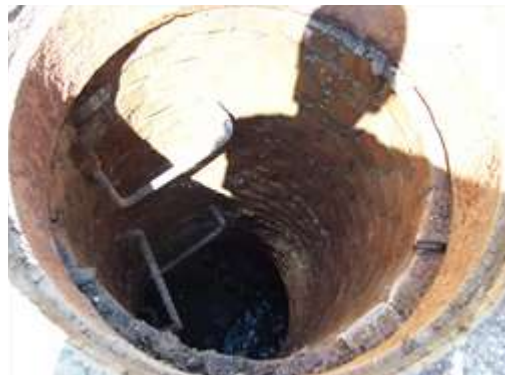
Defect 2

infiltration

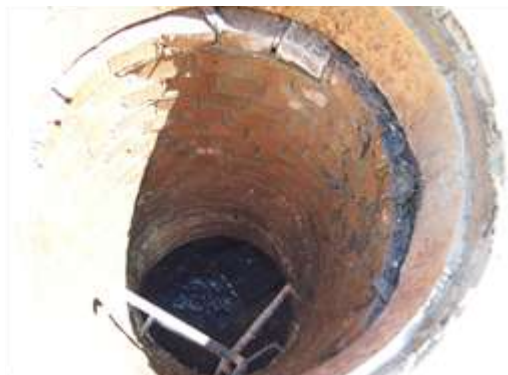
Defect 1

Condition: ☐ Sound ☐ Cracked ☐ Root Intrusion ☒ **Loose Brick** ☐ Deteriorated

Infiltration: ☐ None ☒ **Joint** ☐ Cracks ☒ **Mortar** ☐ Roots ☐ Wall

loose brick

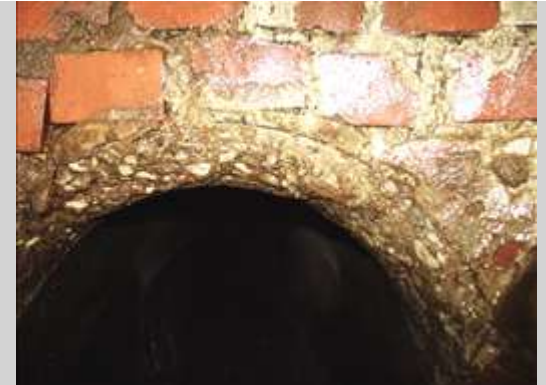
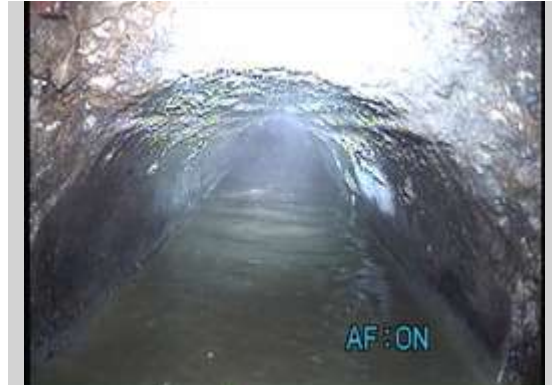
15 in. Circular Gravity Sewer  
Pipe Out @ 12 O'Clock

Pipe Height: **19.2** (in.) Rod and Bar (Angled)  
Pipe Material: **Clay** ☐ Pipe Lined  
Invert Depth: **12.17** (ft.) Flow Characteristics: **Fast**  
Deposits: ☒ None ☐ Mud ☐ Sludge ☐ Debris ☐ Grease  
Silt Depth: (in.) Deposits Extent:  
Infiltration: **None** Pipe Seal Cond: **Sound**

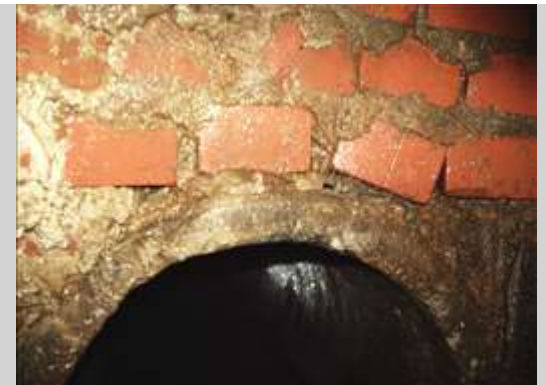
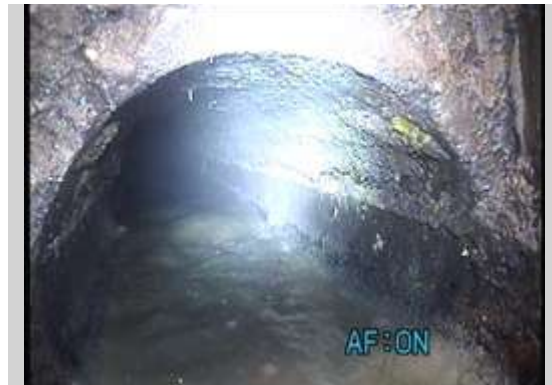
15 in. Circular Gravity Sewer  
Pipe In @ 3 O'Clock

Pipe Height: **19.2** (in.) Rod and Bar (Angled)  
Pipe Material: **Clay** ☐ Pipe Lined  
Invert Depth: **12.25** (ft.) Flow Characteristics: **Fast**  
Deposits: ☒ None ☐ Mud ☐ Sludge ☐ Debris ☐ Grease  
Silt Depth: (in.) Deposits Extent:  
Infiltration: **None** Pipe Seal Cond: **Sound**

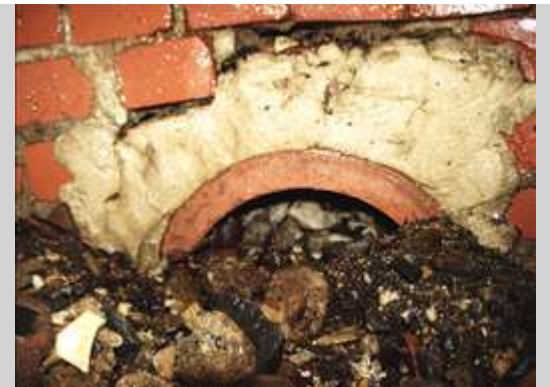
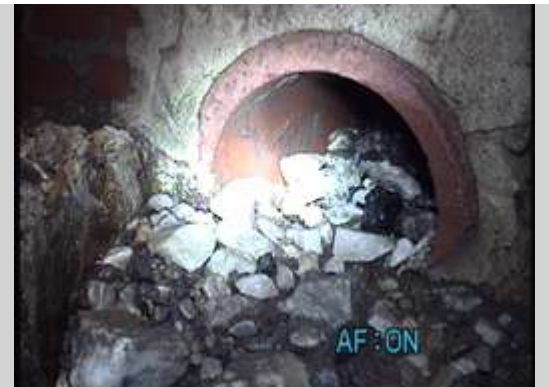
Pipe In @ 9 O'Clock

Pipe Height: (in.) Rod and Bar (Angled)  
Pipe Material: **Clay** ☐ Pipe Lined  
Invert Depth: (ft.) Flow Characteristics: **None**  
Deposits: ☒ None ☐ Mud ☐ Sludge ☐ Debris ☐ Grease  
Silt Depth: (in.) Deposits Extent:  
Infiltration: **None** Pipe Seal Cond: **Sound**

Connects To: **Stub connection / abandoned**  
☐ Possible Illicit Connection
